## AHWG TSB#1–Leaking GDAs Replacement

**Product:** DRV40 & DRV80 Gen. 2

**Technical Assessment Reference:** AHWG TA#1-Leaking GDAs

**Topic/Problem Replacement & Resolution:** Leaking DRV40 & DRV80 Gen. 2 Gear Drive Assemblies

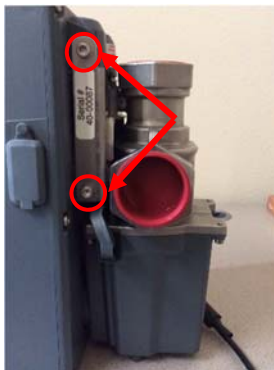
**Figure 2: Plastic Electric Enclosure Access**

1. Power down the DRV40 or DRV80 Gen. 2 by pulling the power cord from the outlet its connected to, or turning off the switch if hard wired
2. Remove the two screws on the right side of the plastic electric housing with the #4mm T handle hex head wrench (*see Figure 2 below*)
3. Disconnect the two connectors and remove the clip on the top hinge pin and rotate the plastic electric enclosure away from the DRV valve body and slide up to remove (*see Figure 3 below*)
  - a. Note – this may be hard wired in, but still needs to be rotated away for accessibility

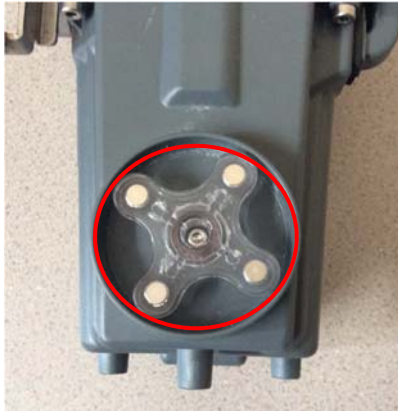
Figure 4: Magnetic Rotor Spindle

5. On the front lower portion of the valve is a magnetic rotor spindle which is held in place with a #2.5mm hex head screw (this is magnetized as a safety feature and must be replaced) *(see Figure 4 below)*
6. Remove the 4 screws holding the bottom plastic cover to the valve body using the #3mm T handle hex head wrench; the plastic cover will slide down and away *(see Figure 5 below)*

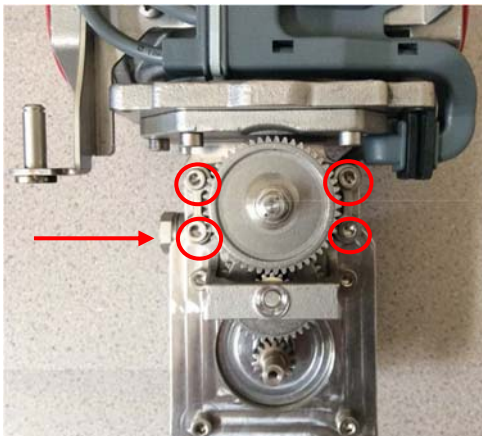
Figure 6: Drain Plug & GDA Screws

7. With the cover removed and facing toward the valve, on the left side of the valve body is the drain plug; remove this with a ½” socket tool & drain water *(see Figure 6 below)*
  - a. Note – slowly remove this as the water pressure & temperature inside the valve may be high
8. Still facing the valve you should now see the present gear drive assembly; remove the 4 screws holding it in place with a #3mm T handle hex head wrench and slide the gear drive assembly away from the valve body *(see Figure 6 below)*
9. Reverse all of above steps to reassemble with new gear drive assembly (p/n D68927)
10. With valve power back on, go in to original programming software and re-calibrate *(see Figure 7 below)*
