WORK ORDER REPORT

Locations: Ontario, CA, Herstal, Belgium

Work Order Summary

Work Order Trap Detail

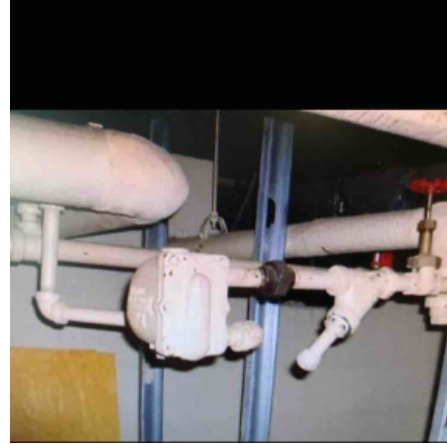
Tag Number 321
 Nests Buildings
 Groups Central
 Elevation (feet) 10
 Physical Location By the boiler

Type Float
 Manufacturer Spirax Sarco
 Model FT125
 Connection Size 1"
 Maximum Operating Pressure (psig) 125
 Connection Type BSPT Threaded
 Condition Blow Thru
 Piping Direction Horizontal
 Steam Pressure In (psig) 10
 Steam Pressure Out (psig) 0

Condensate Recovery Yes
 Application Process
 Insulation Type Fiber Glass
 Installed Date 2014-Nov-15
 Time in service (months per year) 12
 Superheat No

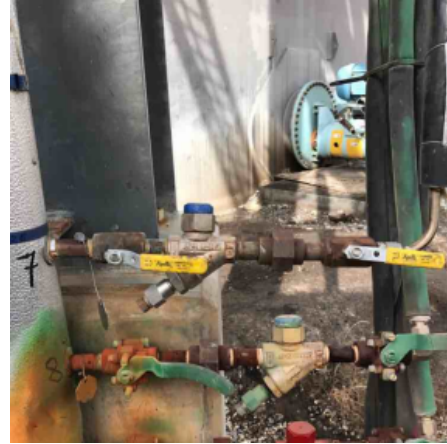
Tag Number 216
 Nests Buildings
 Groups West Wing, Central
 Elevation (feet) 1
 Physical Location By booster pumps

Type Float
 Manufacturer TLV
 Model FS3-21
 Connection Size 1"
 Maximum Operating Pressure (psig) 300
 Connection Type NPT Threaded
 Condition Rapid Cycling
 Piping Direction Horizontal
 Steam Pressure In (psig) 10
 Steam Pressure Out (psig) 0

Condensate Recovery Yes
 Application Drip
 Insulation Type Fiber Glass
 Installed Date 2016-Nov-6
 Time in service (months per year) 12
 Superheat No

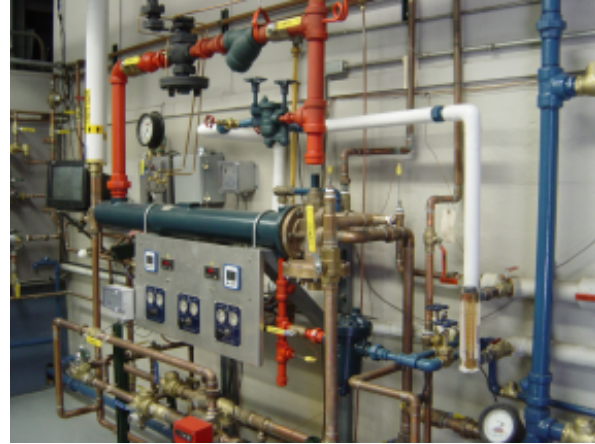
Tag Number 303
 Nests Buildings
 Groups Central
 Elevation (feet) 6
 Physical Location Demo wall

Type Inverted Bucket
 Manufacturer Armstrong
 Model 800
 Connection Size 1/2"
 Maximum Operating Pressure (psig) 20
 Connection Type ANSI Flanged 125#
 Condition Cold
 Piping Direction Stacked
 Steam Pressure In (psig) 10
 Steam Pressure Out (psig) 0

Condensate Recovery Yes
 Application Drip
 Insulation Type Fiber Glass
 Installed Date 2016-Nov-7
 Time in service (months per year) 12
 Superheat No
